CHALLENGE

Water scale deposits had accumulated on a shell and tube heat exchanger at a tire & rubber manufacturing plant.

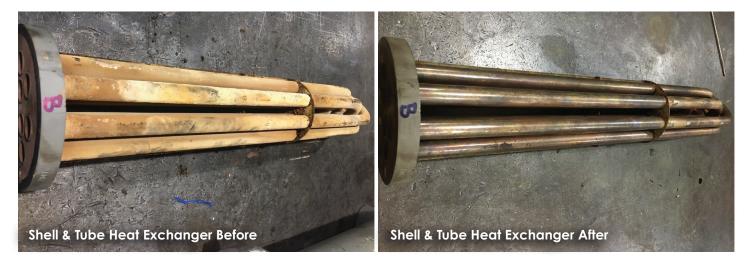
After the **RYDLYME** cleaning, the plant was ecstatic with the results! All heat transfer surfaces were completely clear of water scale deposits to maximize efficiency. The plant will now implement a preventative maintenance program and clean other applications throughout the facility.

A 25% solution of **RYDLYME** was circulated via a PumpMaster 115v descaling system through the heat exchanger for 1 hour.
